Massachusetts FACE Occupational Fatality Report

Laborer Struck by Skid-steer Loader While Exiting from a Tarp-enclosed Area on a Construction Site - Massachusetts

Investigation: # 07-MA-019-01

Release Date: July 28, 2008

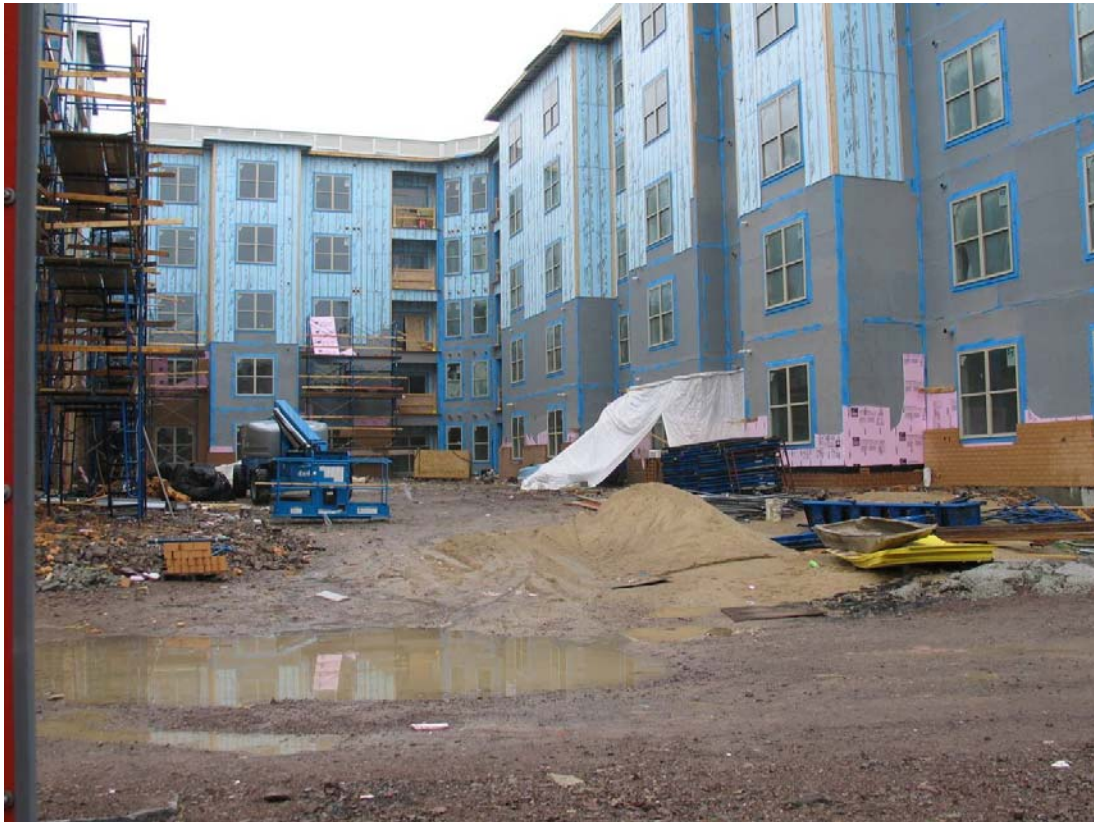
**Figure 1 – Similar location of the incident.
The tarp attached to the building without the scaffolding support.**

At the time of the incident, the company had approximately 14 people on-site and was performing brickwork on the exterior facade of a building (Figure 1). The victim's main job was to mix and supply mortar to the masons. These tasks involved the use of a large mechanical mixer to mix the mortar and the use of a wheelbarrow to transport the mortar to the masons' location.

The incident occurred a few minutes after 8:00 a.m. on a Monday morning. The weather conditions at the time of the incident consisted of temperatures around 40°F with an average wind speed of 16 miles per hour and no precipitation. The incident location was next to a building that was nearing completion. One section of tubular welded scaffolding was set up against the building and was enclosed by two blue tarps. The scaffold was being used as a supporting structure for the tarps that were set up to protect the work area and the workers from the environmental elements (Figure 1). There was no designated entrance or exit location to the tarp-enclosed area. Entering or exiting this area required the lifting of the bottom of the tarp and crouching down to get underneath the tarp.

At the time of the incident, the victim was exiting the tarp-enclosed area with the wheelbarrow to fill the wheelbarrow with mortar. The mortar mixing machine was located approximately 20 feet to the west of the tarp-enclosed area. The victim was crouched down close to the ground lifting up the bottom of the tarp while backing out from underneath the tarp-enclosed area and pulling the wheelbarrow with him at the same time. The victim, in the crouched position, was struck and run over by the skid-steer loader as it passed parallel to the tarp-enclosed area.

Recommendation #1: Employers should ensure that tarp-enclosed areas have designated entrance/exit openings for workers.

Discussion: In this case, the victim and other co-workers would enter and exit the tarp-enclosed area multiple times during the day. This entailed the workers crouching down to lift up the bottom of the tarp and then crawling out. Inexpensive entrance/exit openings that still provide protection from the environment can easily be installed in tarps. One type of opening is the chamber type design. This typically consists of a vertical slit in the tarp with three foot wide strips of tarp material attached to the top of either side of the tarp covering the slit. Another option that could be used is a heavy duty tarp zipper. These zippers are self adhesive and can be installed vertically.

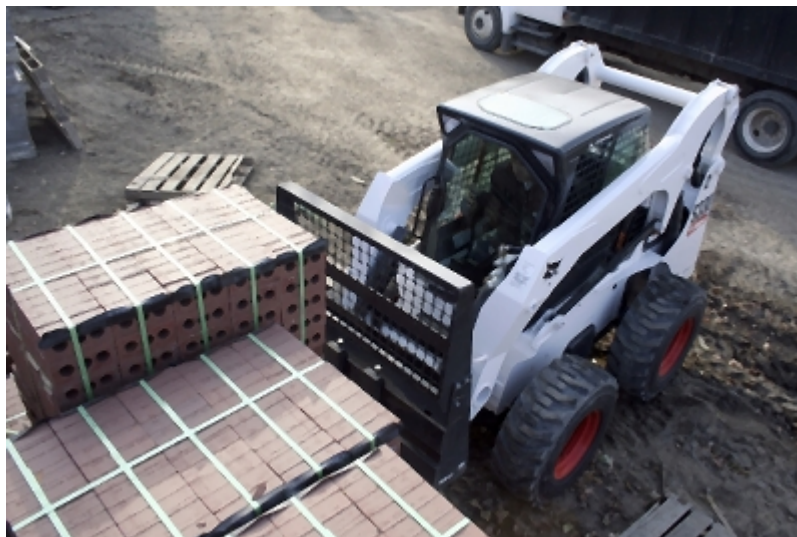
Figure 2 – Skid-steer loader similar to the one involved in the incident.

The masonry company reported that they had two large pieces of equipment on-site at the time of the incident, a lull and a skid-steer. The lull was a rented piece of equipment, and the skid-steer loader, the equipment that was involved in the incident, was owned by the masonry company. The skid-steer loader, manufactured in 2004, is powered by a diesel engine and has rubber tires (Figure 2). Without attachments, the skid-steer loader is approximately ten feet long, six feet wide and over six feet high (to the top of the cab). The cab of the skid-steer loader completely encloses the seated operator. At the time of the incident, the fork attachment was being used on the skid-steer loader to transport bricks and blocks on pallets to the different areas of the construction site.

Prior to the incident, the victim was inside the tarp-enclosed area and a co-worker was operating the company's skid-steer loader in the forward direction. The co-worker was driving the skid-steer loader parallel to the tarp-enclosed area to load a pallet of bricks onto the skid-steer loader's forks. The pallet of bricks was located approximately 50 feet north of where the incident occurred. The skid-steer loader's forks were in a lowered position and did not have a load on them at the time of the incident.
